Gihon River Corridor Plan

Johnson, Hyde Park, & Eden, Vermont
October 30, 2009

Johnson, Hyde Park, and Eden, Vermont

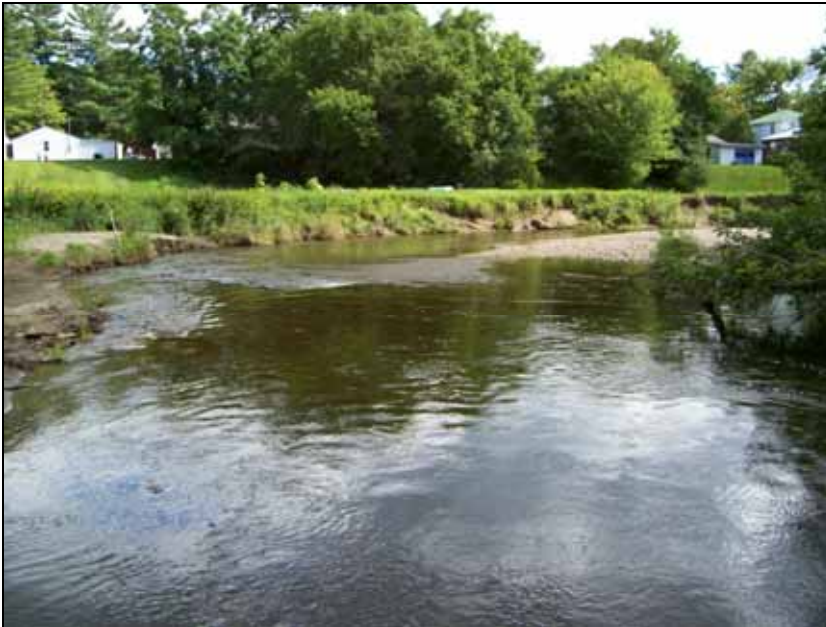
The active adjustments recently observed include major aggradation and planform adjustment as well as minor widening. These adjustments are a result of the river working to create a new floodplain due to historic degradation which has caused the stream to incise.

Reach M01-A is undergoing major planform adjustment, aggradation, and minor widening.

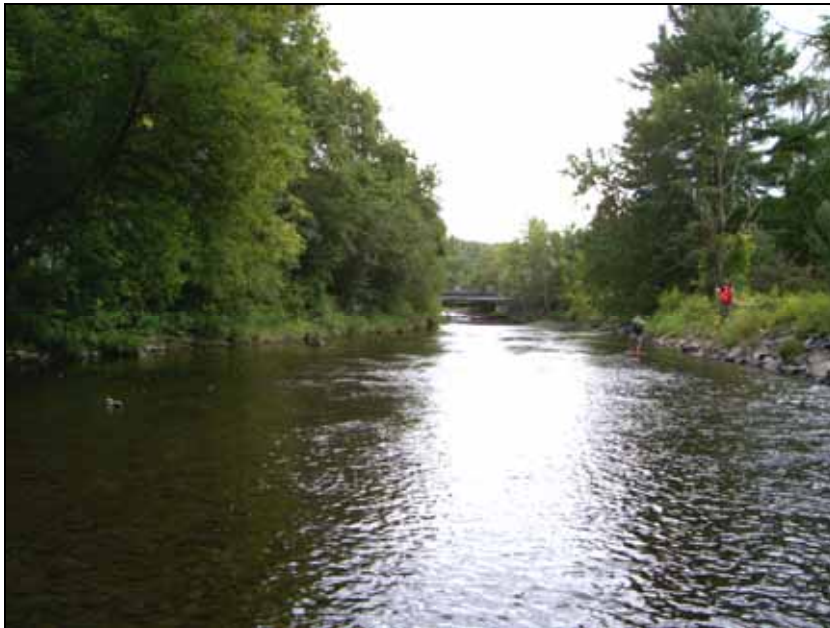
Gihon segment M01-B begins below a bedrock waterfall upstream from downtown Johnson. The segment flows through a historically straightened section, past an old mill site (now housed by the Vermont Studio Center) under the Pearl Street Bridge and eventually ends 2453 feet downstream of a long section of rip rapped, channelized streambank. From above the first grade control (at the former mill), the reach has not incised significantly; however, downstream of the Pearl St. Bridge, the Gihon River has an incision ratio of 1.5. It is likely that without the significant investment in streambank armoring, the channel in this segment would be exhibiting much higher rates of channel widening and planform adjustment (which were still noted as major). Due to the anthropogenic disturbances observed in this reach, the Gihon River no longer has a riffle-pool bedform and is instead a plane bed system.

Reach M01-B is a plane bed stream due to historic channel straightening through the village of Johnson. Bank armoring has limited widening and planform adjustment

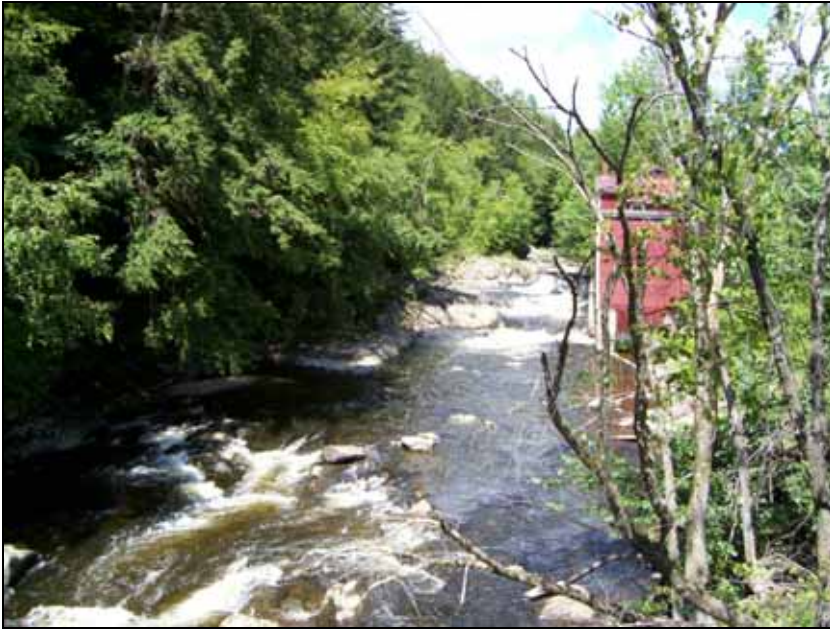
Gihon River reach M02 is a short, bedrock dominated channel 1922 feet long. The reach begins where the Gihon River takes a sharp "S" curve bend across from Lambert Lane, upstream of Johnson Village. The reach drops steeply through a series of bedrock ledges and waterfalls passing near an old powerhouse. It continues under the Powerhouse Covered Bridge ending several hundred feet downstream where the stream type changes. Although the reach was not fully assessed due to the bedrock influence in the channel, it was noted that route 100C has encroached on the east corridor reducing the quality of the riparian buffer.

M02 is a bedrock controlled channel and the site of a former dam

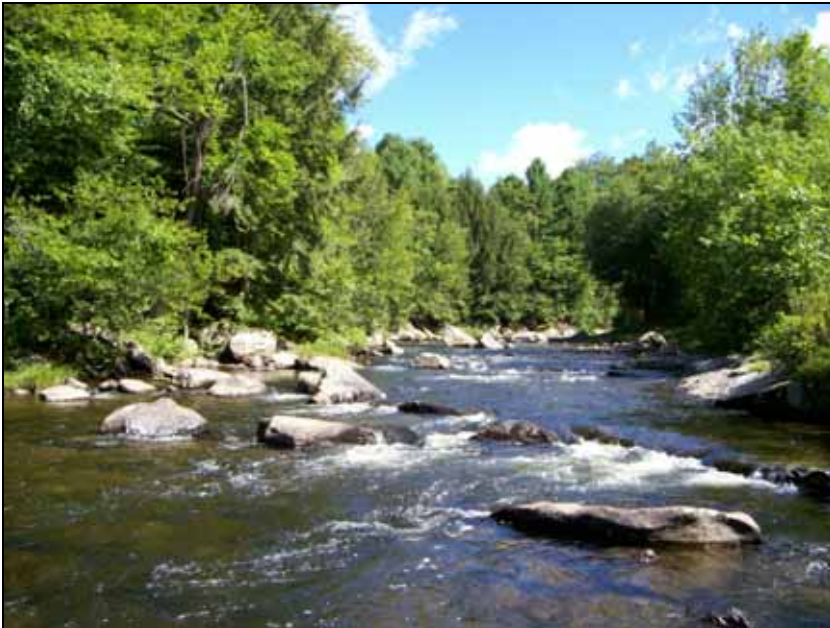
The reach appeared to be undergoing some major widening and is receiving sediment from upstream. Naturally occurring bedrock and large material in the stream channel have likely assisted in the overall stream stability of the reach.

M03 has large material and bedrock in the channel which has helped reduce instability

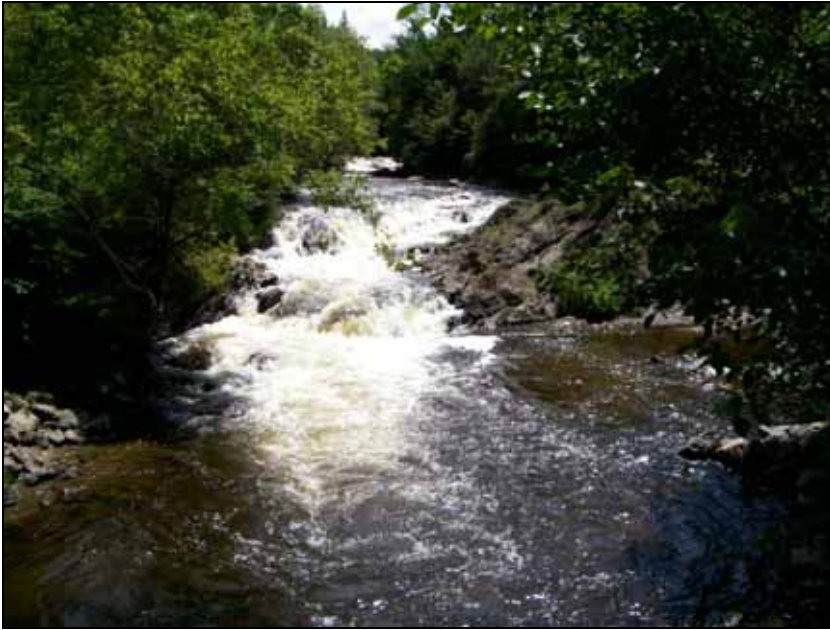
Gihon segment M04-A begins at a bedrock grade control several hundred feet upstream from the Route 100C bridge. From this point, bedrock dominates the bed and banks of the river as it drops steeply over several waterfalls and cascades. Due to the inherent stability of a bedrock gorge, this reach was not assessed for geomorphic condition.

M04-A is a bedrock controlled segment

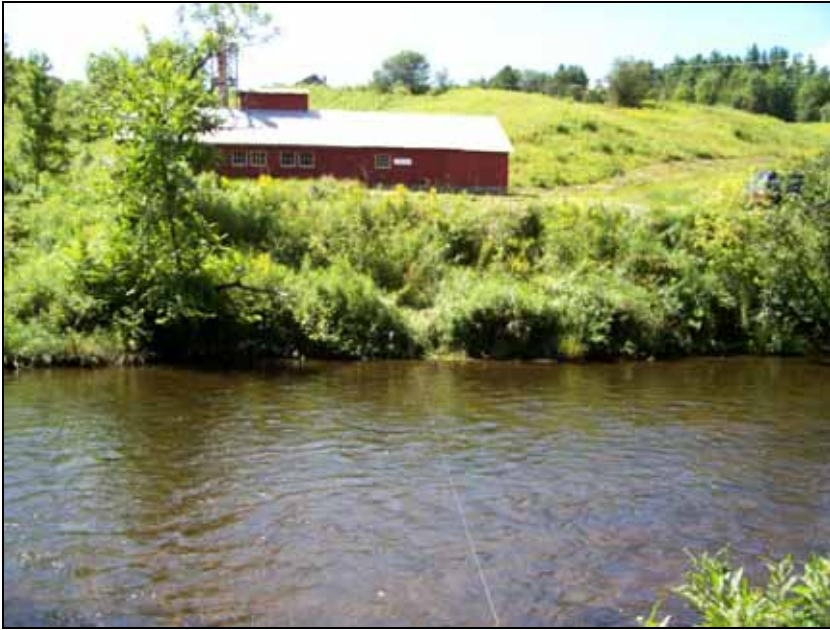
Gihon River segment M04-B begins where Sinclair Road comes next to the river channel. This short segment extends downstream (850 feet) to the beginning of a bedrock controlled segment. The segment is a “B” type channel that marks the transition between a very broad valley upstream and a semi-confined bedrock channel in segment M04-A. This segment is predominately a transport channel, although a small amount of floodplain exists. It appears as if the stream or floodplain may have experienced minor straightening or filling during the construction of Sinclair Road. Currently only minor widening, aggradation, and planform adjustment were observed.

M04-B is a transitional segment between a very broad and semi-confined valley (B type channel)

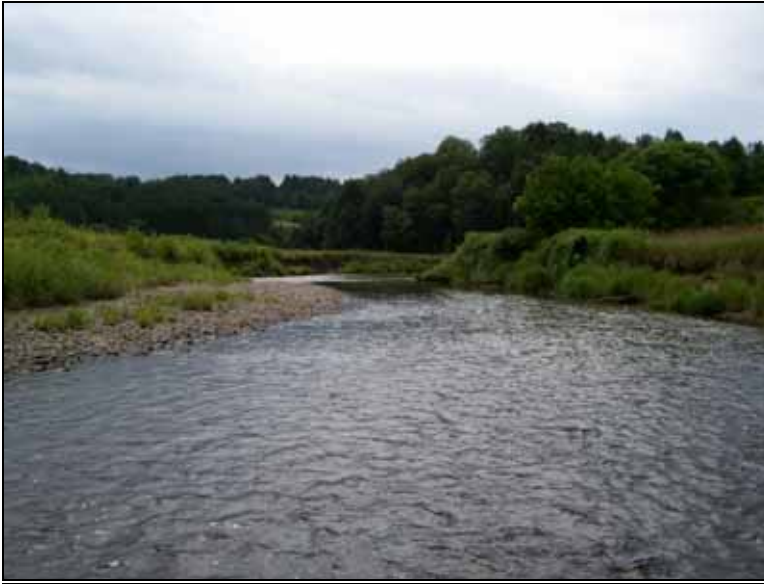
The bridge at the Rocky Road crossing was identified during the Phase 2 assessment as being both undersized and having a poor alignment. These two factors are causing localized geomorphic instability. It is recommended that this bridge be further evaluated using the Vermont Agency of Natural Resources Bridge and Culvert Assessment protocol to determine the priority for replacement

M05 has historically incised and is currently undergoing major planform adjustment and aggradation

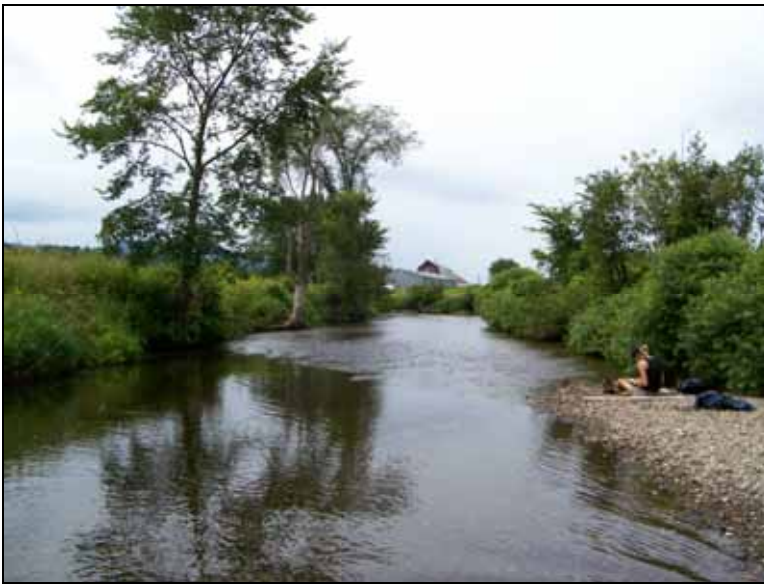
Gihon River reach M06 flows through predominately agricultural fields upstream of the Schribner Covered Bridge (Rocky Road). Agricultural impacts on this reach have reduced the buffer to less than 5 feet in width along almost the entire reach. Historic channel straightening may be the cause of the channel incision (1.3 ratio) that was observed in this reach. As a result of this incision, the reach is currently undergoing major planform adjustment and minor widening as the river attempts to redevelop a new floodplain.

M06 has historically degraded and is currently undergoing major planform and minor widening adjustment

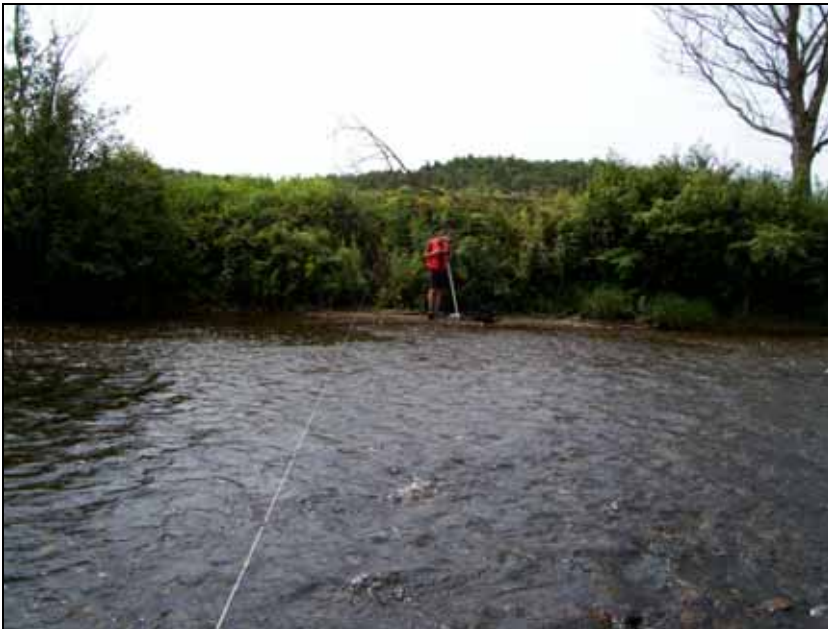
Gihon Reach M07 begins several thousand feet upstream from the Schribner covered bridge on Rocky Road where the valley walls of the Gihon River open up and the stream transitions from a bedrock controlled channel to a very broad alluvial valley. The dominant corridor land use within this reach is agriculture. Agricultural activities have impacted the riparian buffer which averages less than 5 feet in width on each side of the channel. Historic channel straightening may be the cause of the channel incision (1.4 ratio) that was observed in this reach. As a result of this incision, the reach is currently undergoing major planform adjustment and minor widening as the river attempts to redevelop a new floodplain.

M07 has historically incised, as depicted in this photograph

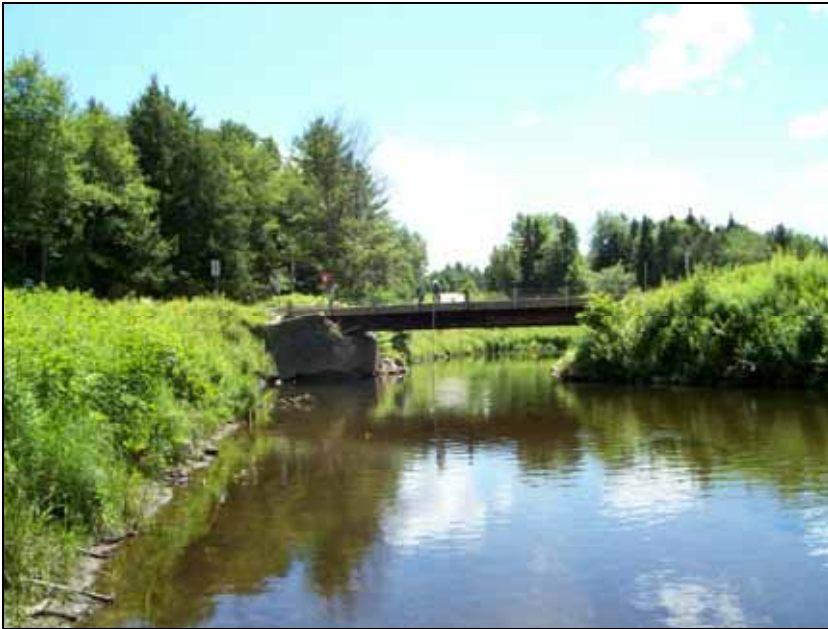
Gihon River segment M09-A begins upstream from Whitcomb Island Road. It continues for 1076 feet downstream to the M08 reach break. This segment has reduced water surface slope due to the run of the river dam on reach M08. Due to this change in hydrology, this reach was excluded from a full Phase 2 geomorphic assessment. It was observed, however, that the riparian buffer in this reach has been reduced to less than 5 feet in width through most of the segment due to residential development and clearing near Barnes Road on the east bank.

Segment M09-A is impacted by a dam at the downstream end of the reach. It was excluded from a full geomorphic assessment due to the backwater effect of the dam

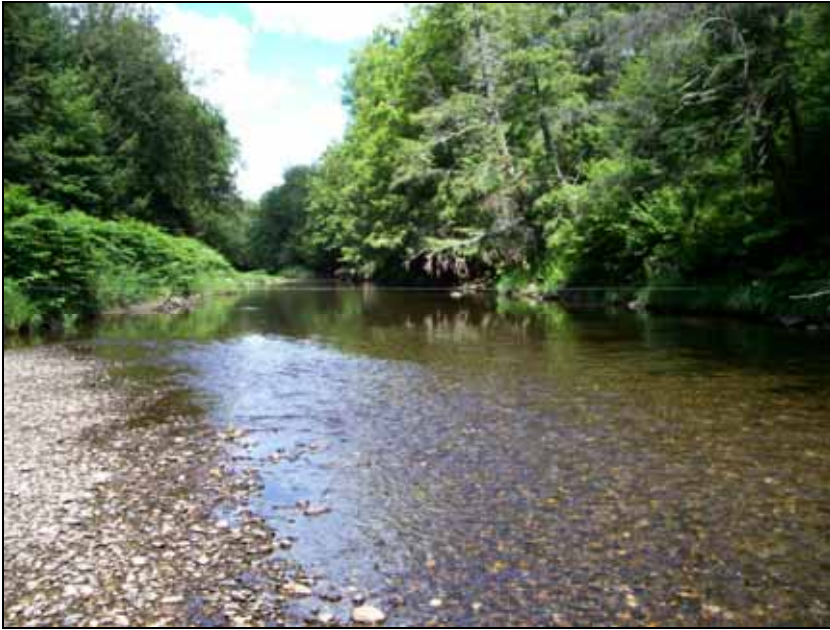
Segment M09-B begins about 2500 feet upstream from the Whitcomb Island Road Bridge where the valley width of the Gihon River changes from very broad to narrowly confined. The upstream end of this reach is a B channel dominated by gravel substrates. There are, however, large bedrock outcrops that run through portions of this reach and exposed slopes along the valley walls are consistently bedrock. Due to the very stable nature of the bed and banks, this reach has not incised. It remains a B channel with a healthy riparian buffer (>100 feet in width on both banks). There is some evidence of minor channel widening in this segment which appears to be a reaction to minor channel aggradation associated with streambank erosion upstream.

Segment M09-B is a naturally occurring B channel in a confined valley that has bedrock outcrops and a healthy riparian buffer on both banks.

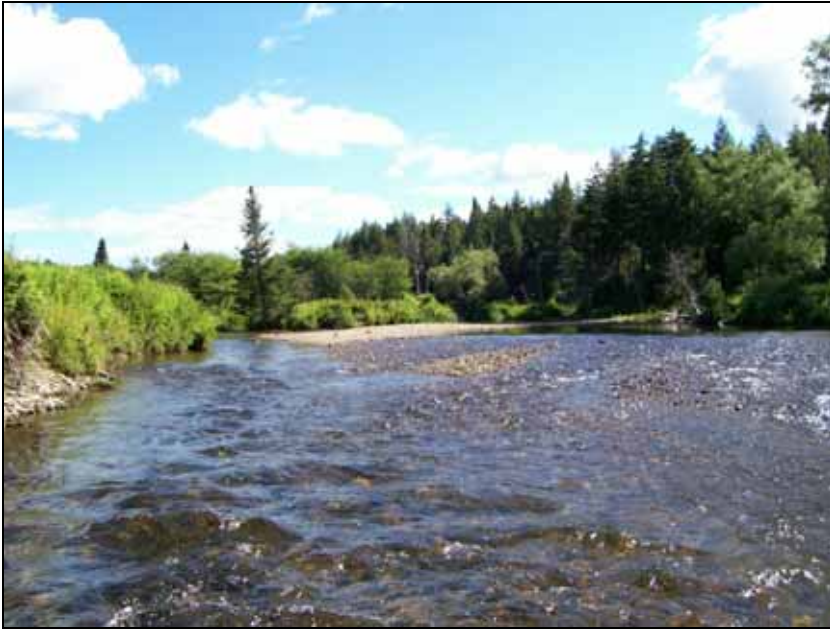
Gihon River reach M10 is located predominately within the Town of Johnson. A small portion of reach M10 is Hyde Park. Reach M10 is an actively adjusting channel that flows through predominately forested lands about half-way through the study area. The reach begins below a bedrock dominated section, and ends at a bedrock falls where it comes near Barnes Road. In between these two bedrock grade controls is Gihon reach M10, an incised channel (incision ratio of 1.4) that is undergoing extreme planform adjustment along with major aggradation and widening. The reason for these adjustments is not obvious, however numerous neck cut-offs, channel avulsions, flood chutes, and bars are evidence of a highly active channel. Fortunately, there is no significant infrastructure within the river corridor of this reach which remains well forested. The ability of the Gihon River to adjust through this reach and redevelop a floodplain, will likely contribute, overtime, to stability and flood reduction in downstream reaches.

M10 is undergoing extreme planform adjustment along with major widening and aggradation

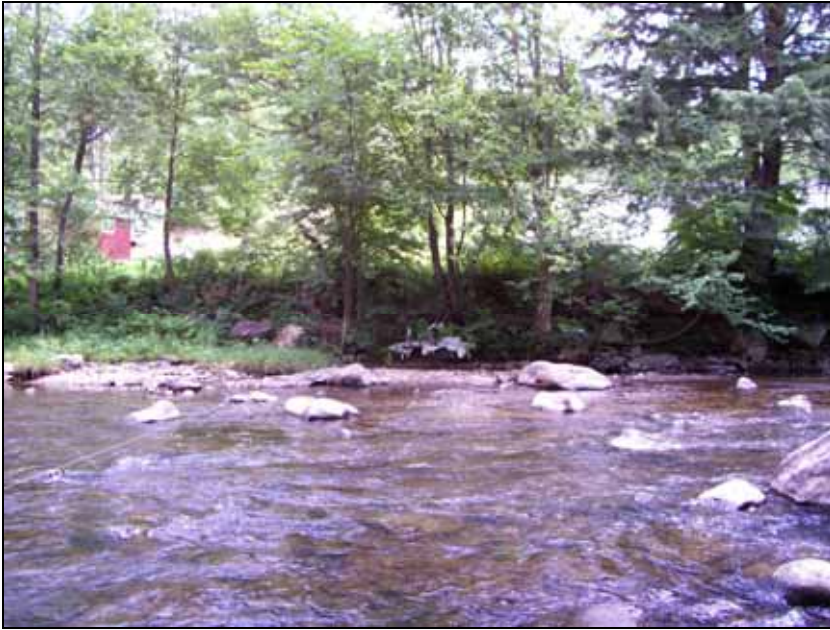
Channel armoring on both banks was present and the riparian buffer on the east bank has been reduced to less than five feet in width. Major channel widening was recorded as the dominant current channel adjustment process within this segment.

MII-A is widening as a result of historic channel incision

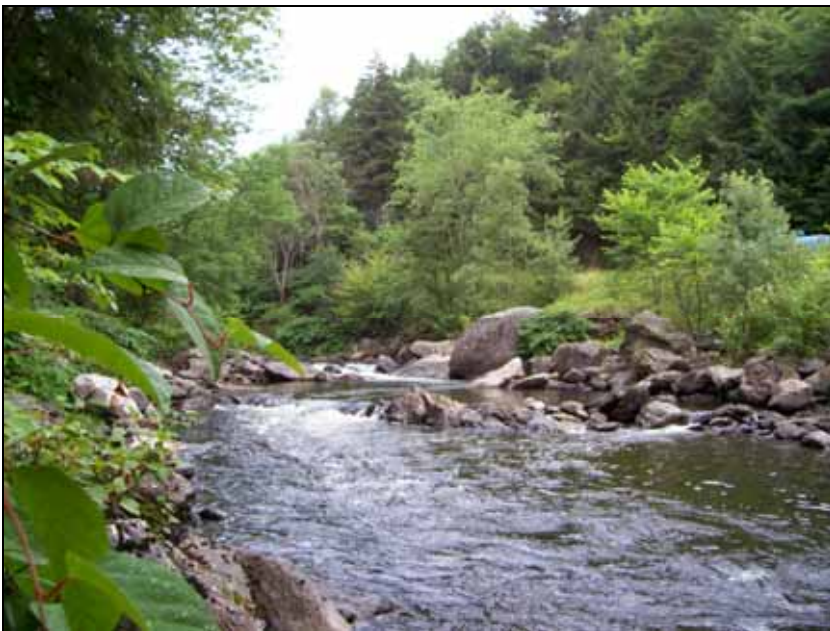
Segment M11-B is a short (1107 feet) segment dominated by bedrock grade control and bedrock outcrops on the banks. Although the riparian buffer has been significantly disturbed on the east bank, due to Wilson Road, the highly stable nature of the bank and bed material has contributed to the overall stability of this stream. A partial assessment was conducted on this segment due to the bedrock influence.

MII-B is a bedrock dominated channel intersected by Wilson Road

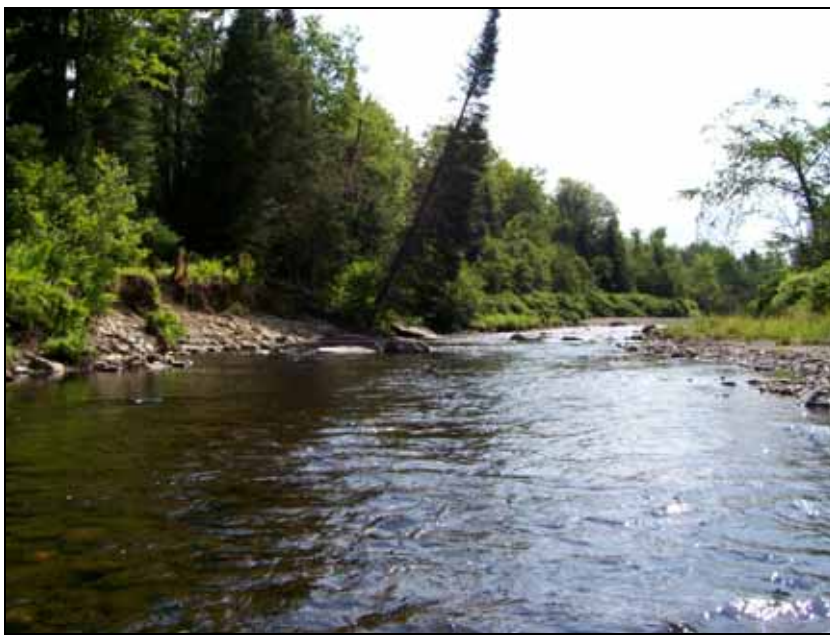
Gihon River reach M12 begins about 2500 feet downstream of the junction of Route 100 and 100C in North Hyde Park and continues downstream to where the valley walls of the Gihon confine the river just upstream from the Wilson Road Bridge. This reach exhibited no indication of recent channel incision. A bedrock grade controlled segment (M11-B) downstream is likely preventing incision within this reach. The river within this section, however, is undergoing a process of extreme planform adjustment as well as major aggradation and widening as it adjusts to alterations in sediment load and flow that have occurred upstream. With the exception of a few structures high on the west valley wall, the river in this reach is able to undergo extreme adjustments in a well forested corridor.

M12 is undergoing extreme planform adjustment

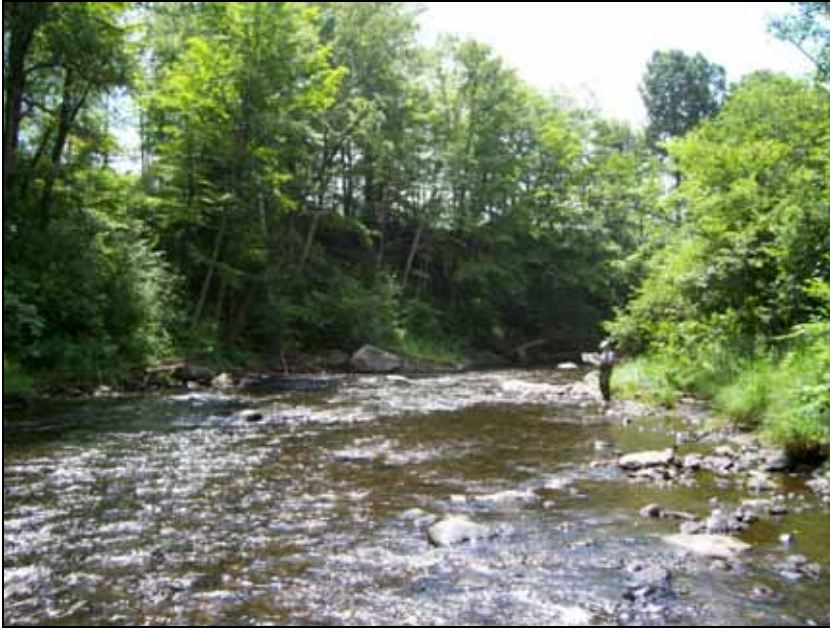
adjustment and minor widening and aggradation were observed to be occurring as the stream works to redevelop a floodplain.

M13-A is undergoing major planform adjustment as a result of historic streambed incision

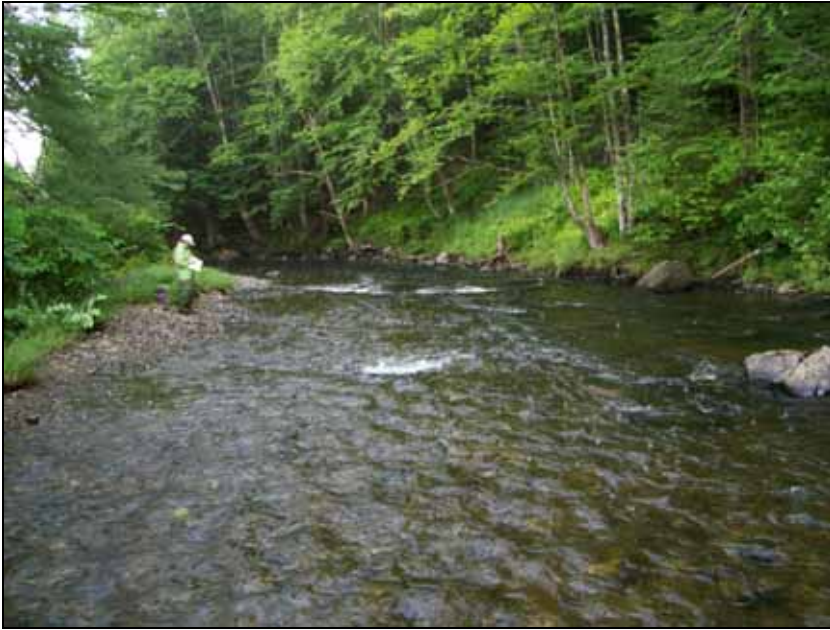
Gihon segment M13-B begins just below the furniture mill in North Hyde Park and flows downstream through the village. Despite large encroachments into the river corridor on the east bank due to the village, the stream through this upper segment (1508 feet in length) has retained some floodplain access as a C type stream. Historic channel incision was recorded in this reach (incision ratio of 1.7) in addition to current major planform adjustment, minor widening and aggradation. Due to residential encroachment, the riparian buffer on the east bank has been reduced to less than 25 feet in width.

M13-B is adjusting its planform as a result of historic channel incision

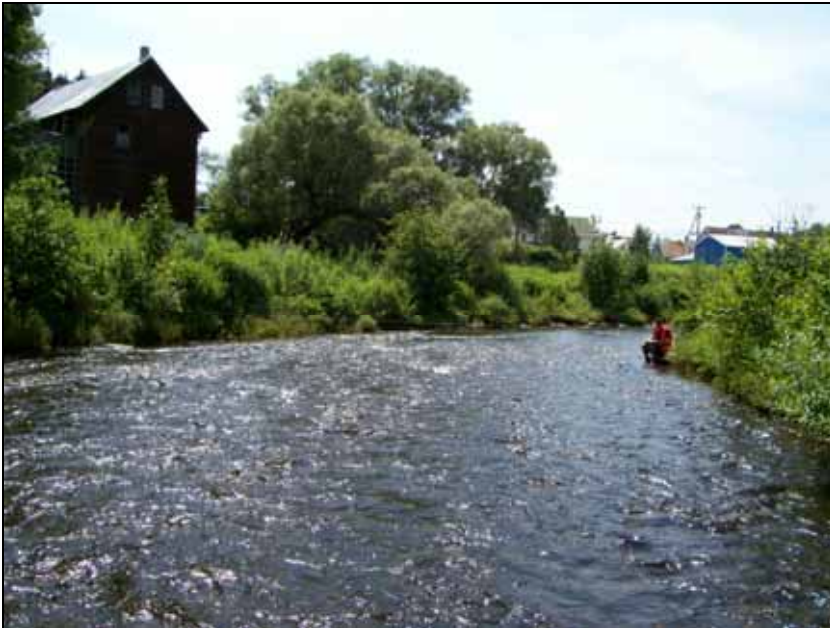
Gihon segment M14-A does not appear to have undergone recent incision. The reach has retained a riffle-pool bedform which may be a result of the moderate sinuosity and floodplain access which has been preserved in most of this segment. Surrounding land use in the corridor is dominated by residences. The riparian buffer along this reach has been impacted by residential development, which has reduced the buffer to between 0 and 25 feet in width through most of the reach. Despite these impacts, and some significant confinement of the channel and floodplain in the vicinity of the Route 100 Bridge, the river appears to only be undergoing minor planform adjustment and widening in this section.

M14-A has minor widening and planform adjustment

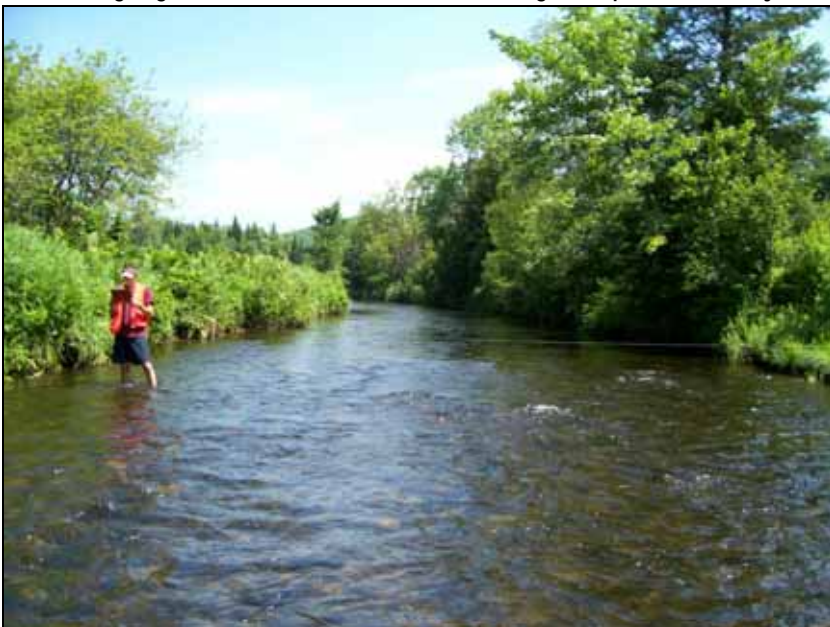
Gihon segment M14-B is also an incised channel that is thought to have been historically straightened for agricultural purposes. The major channel straightening has caused the bedform to be a weak riffle-pool system. The riparian buffer on both banks has been significantly disturbed. As a result of these anthropomorphic disturbances the river is exhibiting signs of minor channel widening and planform adjustment.

M14-B is widening in response to historic channel straightening and incision. The riparian buffer on both banks has been greatly impacted by agriculture and residential land use

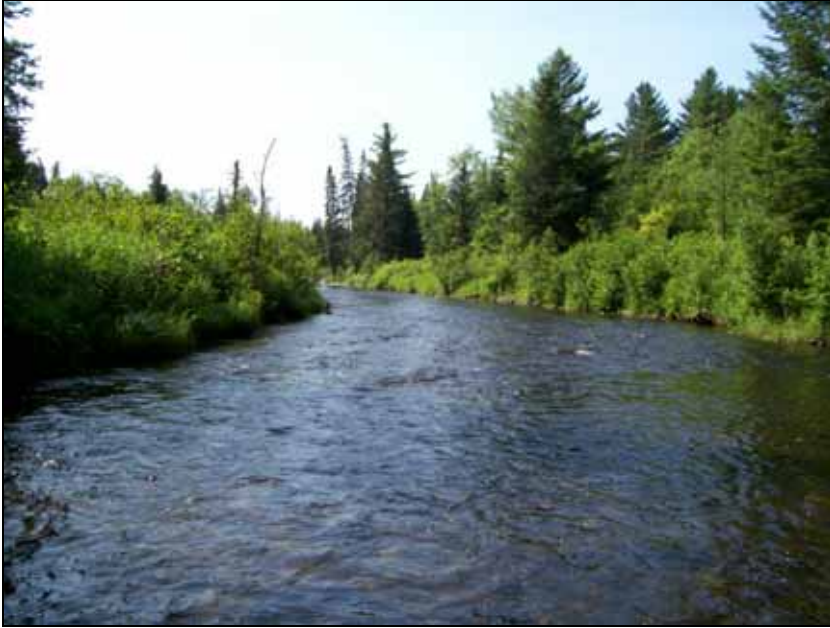
Segment M14-C flows through a forested corridor. The river through this reach is only slightly incised and numerous floodplain wetlands were found within the stream corridor. Evidence of minor channel widening, aggradation, and planform adjustment were observed to be occurring in this reach as a result of the incision. However, a very healthy riparian buffer is likely slowing these adjustment processes.

M14-C is somewhat incised with only minor channel widening, planform, and aggradation

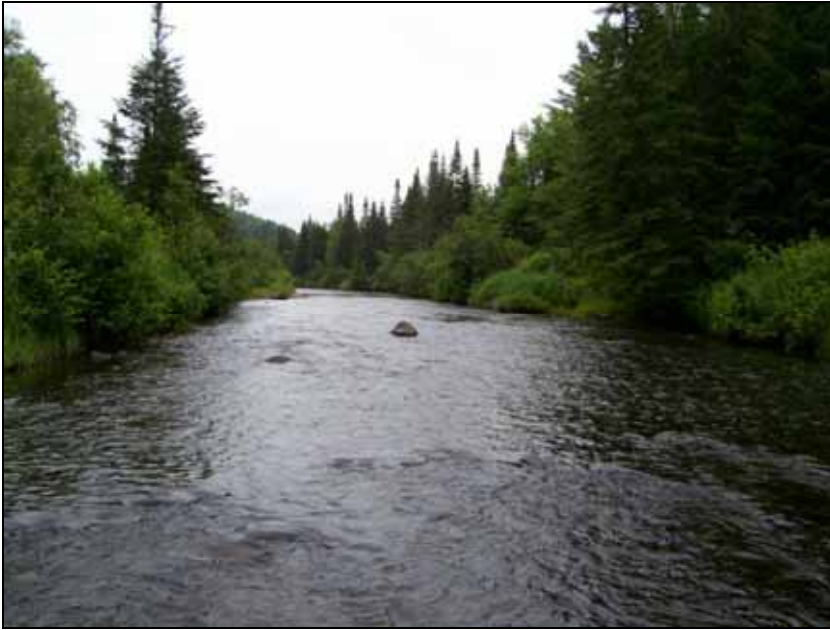
Gihon River reach M15 begins at the confluence with the Stoney Brook in Eden and flows downstream through a broad valley for nearly a mile to where the valley walls widen north of North Hyde Park Village. Flowing through a dense, not recently disturbed forest, this reach appeared to be in good geomorphic condition. Minor widening, aggradation, and planform adjustments were observed in this reach which may be a result of instability upstream.

M15 flows through a heavily forested corridor and has good geomorphic stability

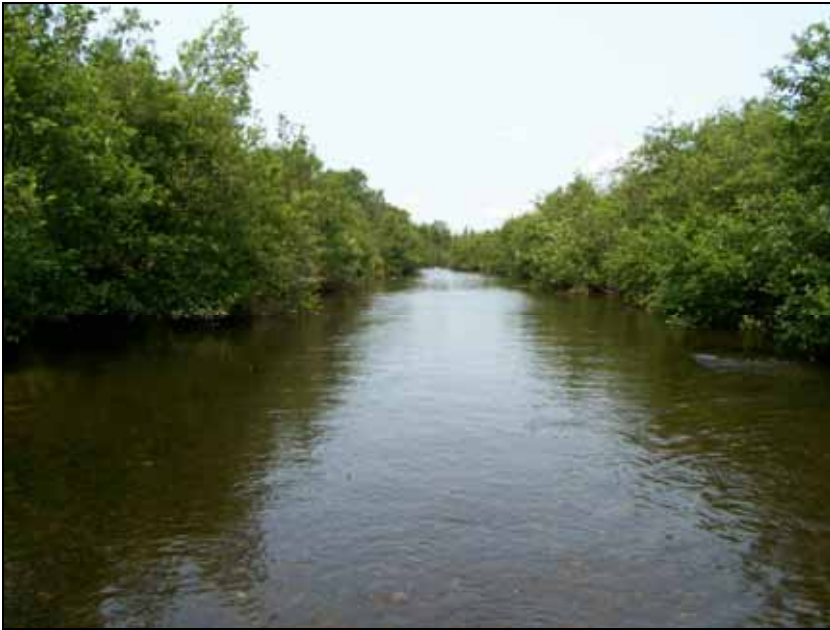
Gihon River segment M16-A begins about 800 feet upstream of the Stoney Brook confluence. The stream through this area has excellent floodplain access along the east bank, which is dominated by alder and a mixed forested buffer. Although the stream is fairly straight through this short segment, it appears very stable, which may be a result of the very dense alder vegetation that is growing on the bank. No major stream channel adjustments were observed in this segment.

M16-A is a C channel with very densely vegetated banks that have likely assisted in keeping the channel stable

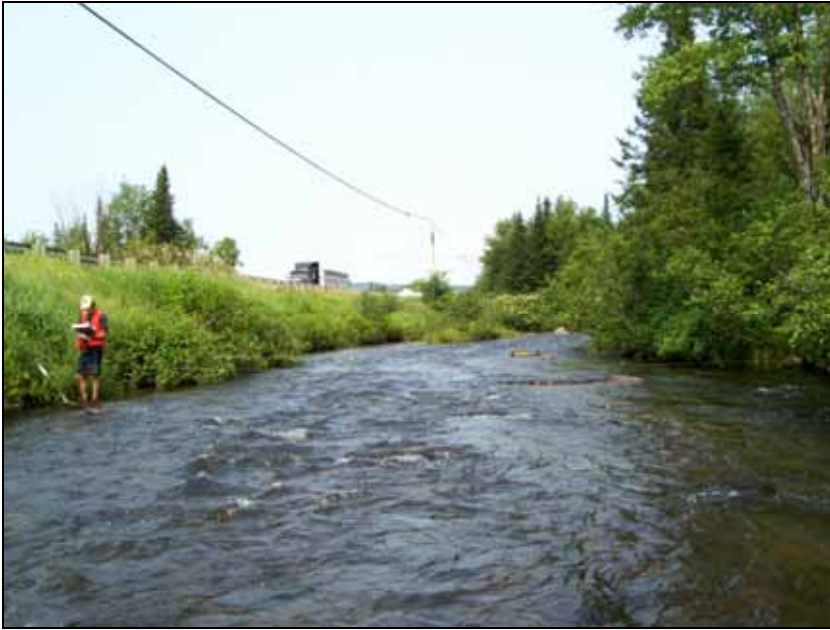
Route 100 has changed the planform and channel confinement of M16-B

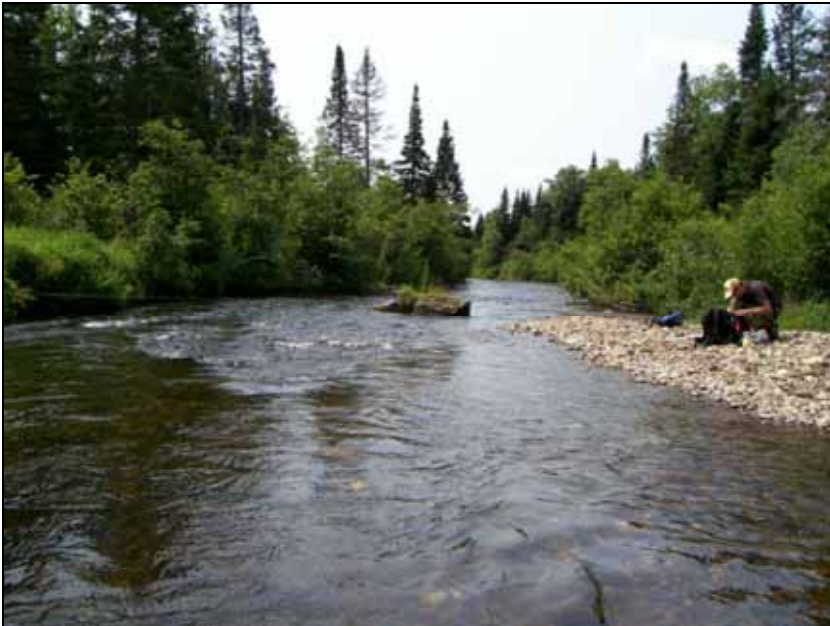
M16-C is a C channel that is widening and adjusting planform

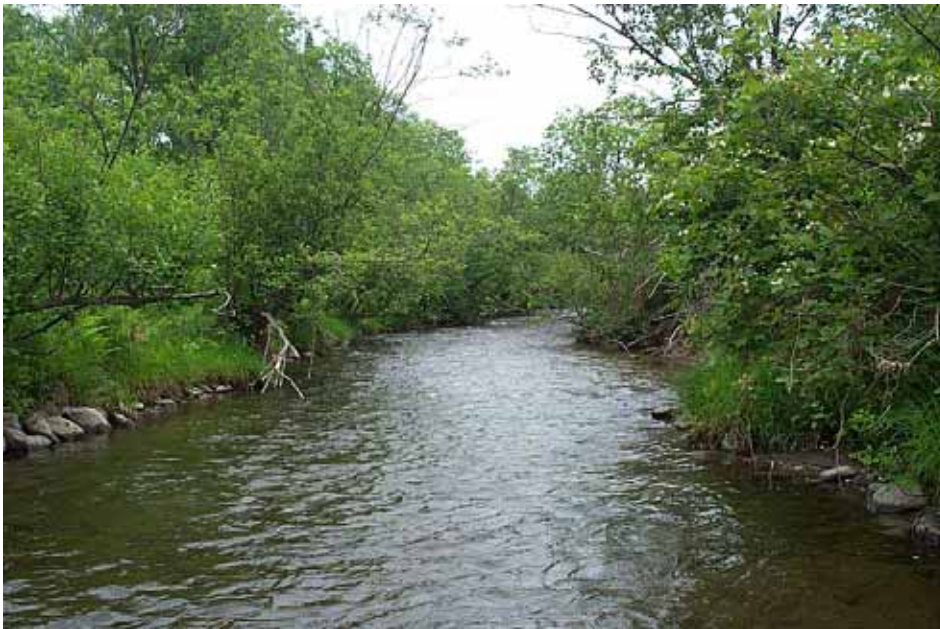
M17-A has been historically straightened and is now has a plane bed form

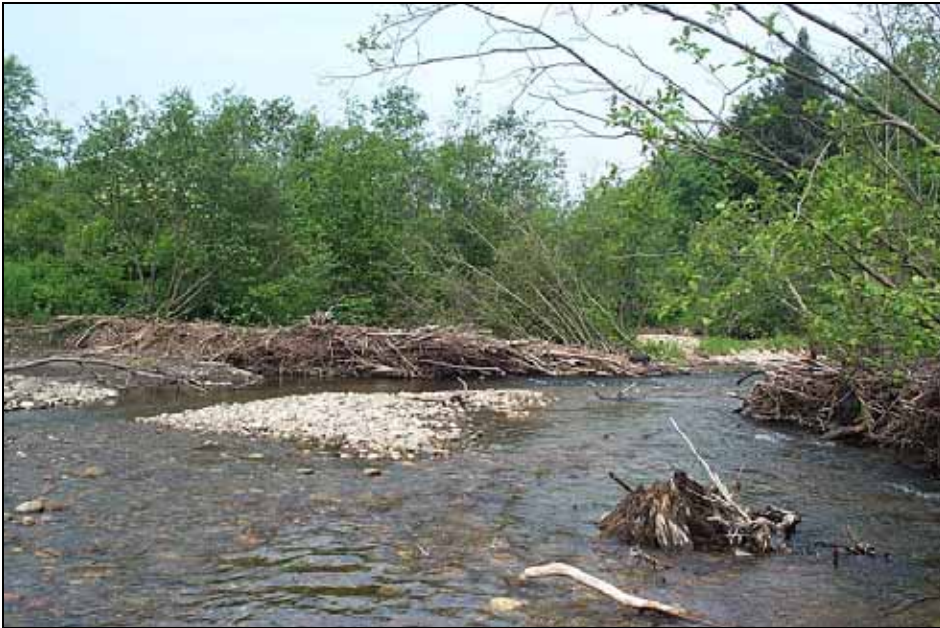
Gihon segment M17-B is heavily influenced by beavers which have created excellent habitat, despite a geomorphically active channel

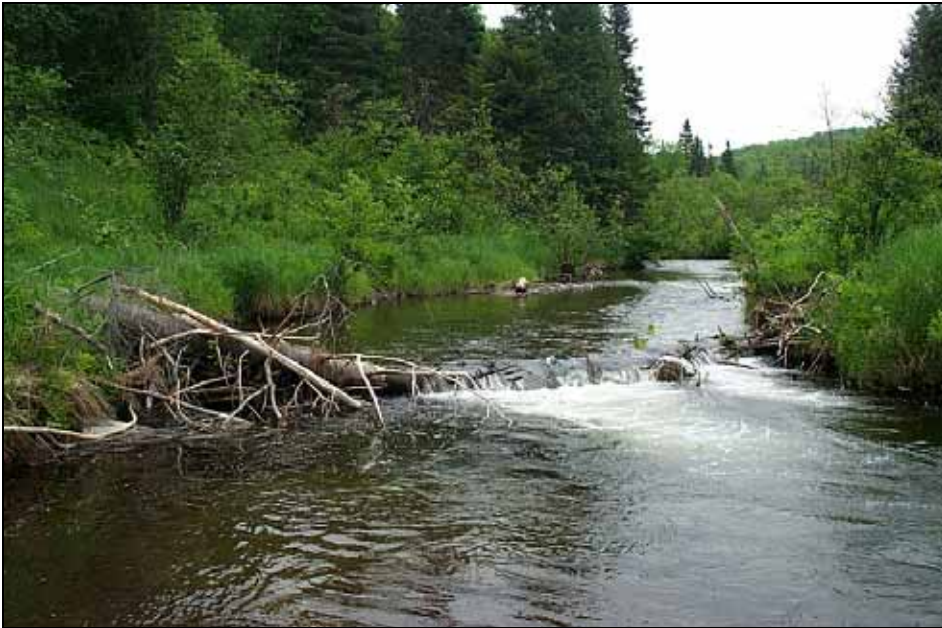
M18-A is in very good geomorphic condition. In-stream woody vegetation in this segment offers good instream habitat

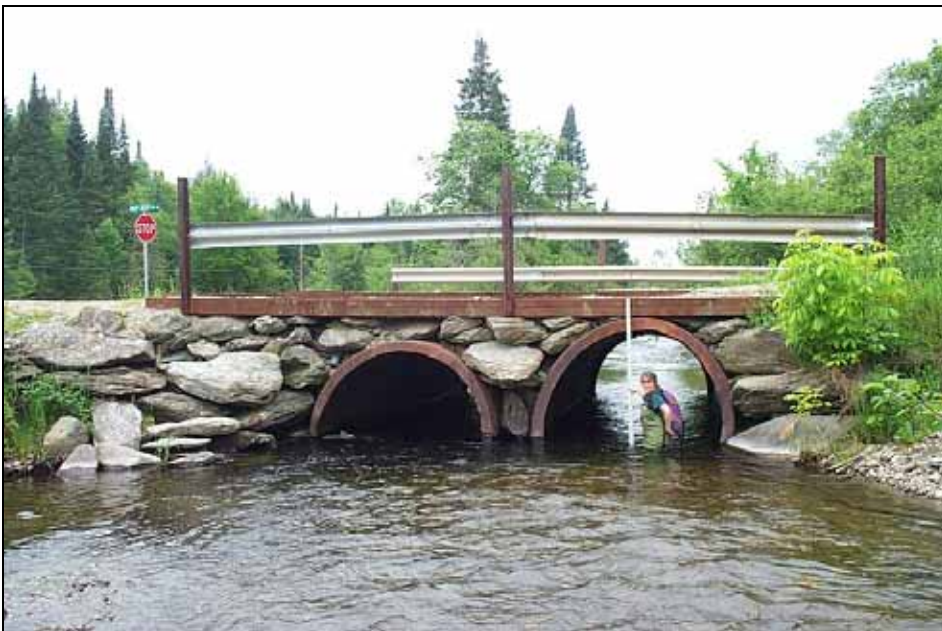
Twin culverts in M18-A high priority for replacement

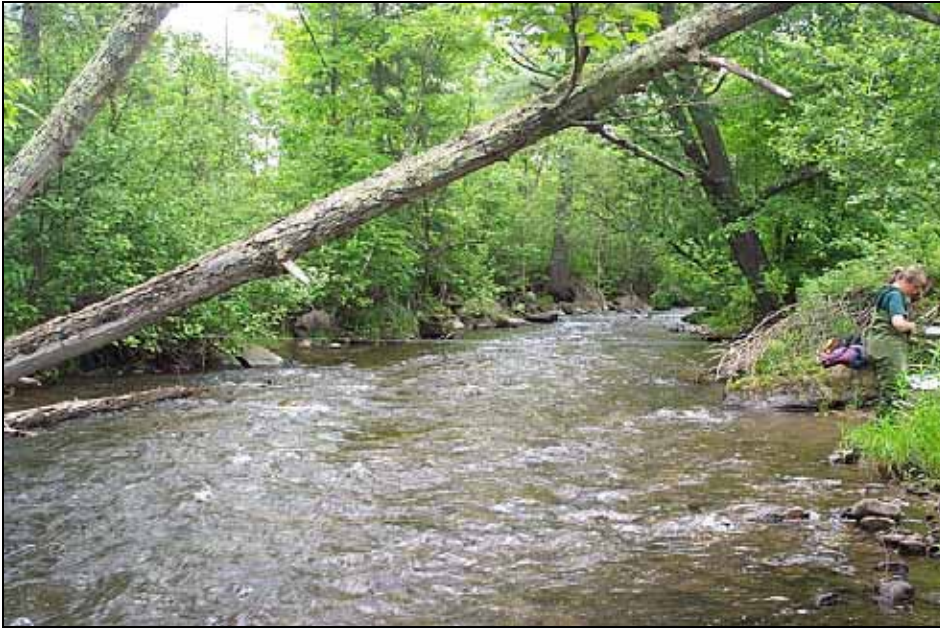
Segment M18-B has been historically straightened. It is an incised channel that is currently undergoing minor channel widening, aggradation, and planform adjustment

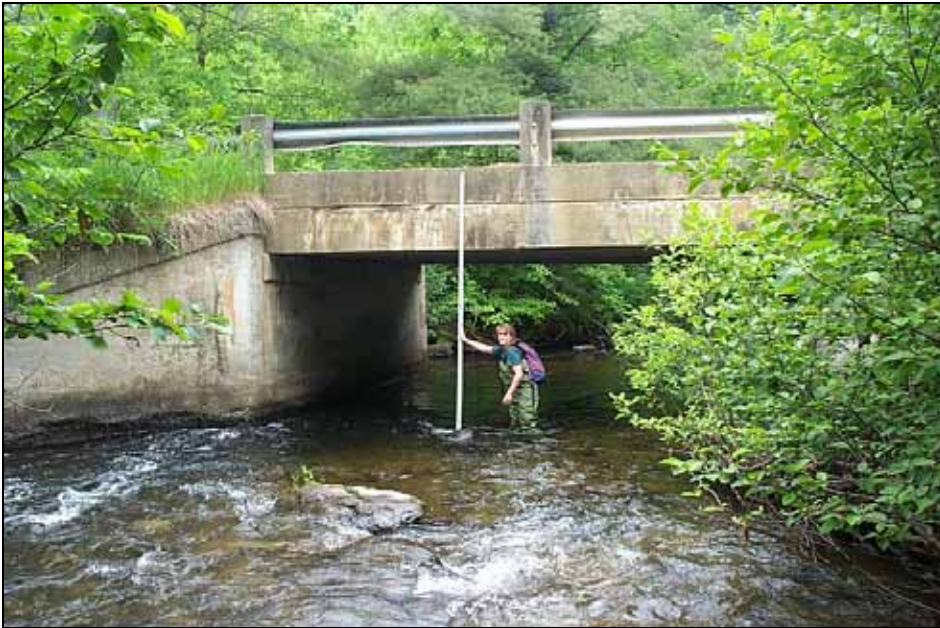
Undersized bridge in M18-B identified as a priority for replacement
