# Town of Belvidere Road Erosion Inventory Report

**Lamoille County Planning Commission**

**December 2019**

*Inventory and report funded by the Vermont Agency of Transportation 2019 Better Roads Program*

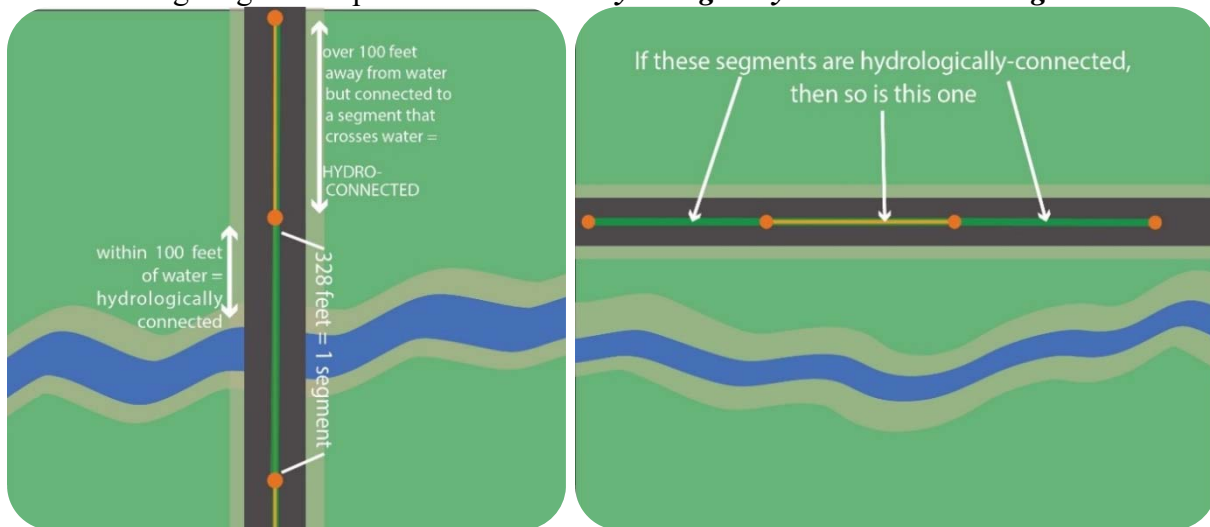
The following diagrams depict the criteria for *hydrologically connected road segment*:

\*Diagrams created by Two Rivers-Ottauquechee Regional Commission staff

Hydrologically connected road segments are indicated by one or more of the following:

- Within 100 feet to water resources (streams, rivers, wetlands, lakes, ponds)
- Road segments that bisect a water resource
- Adjacent segments to connected segments (i.e. segment uphill of a connected segment)
- Catch basin outfall pipe at 500 feet or less from a water resource

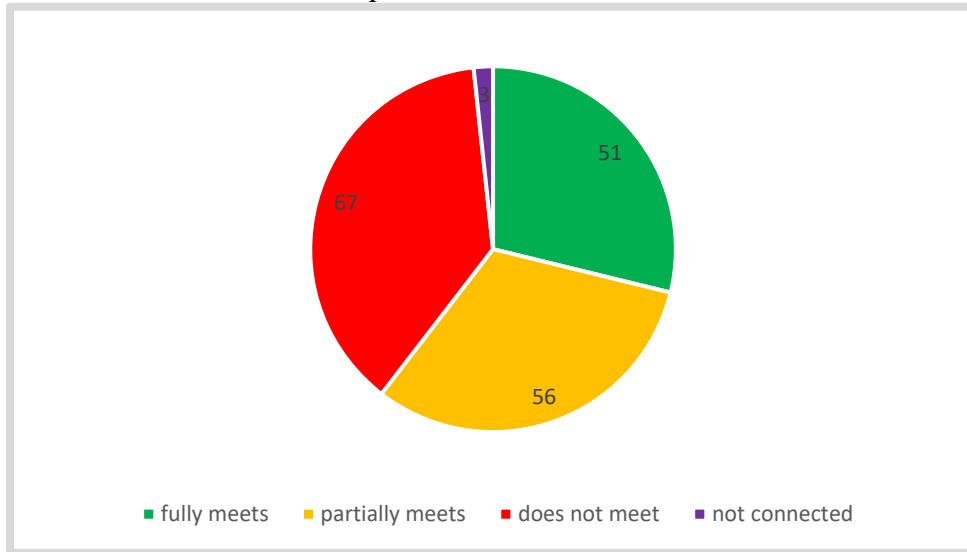
This pie-chart summarizes MRGP compliance status:

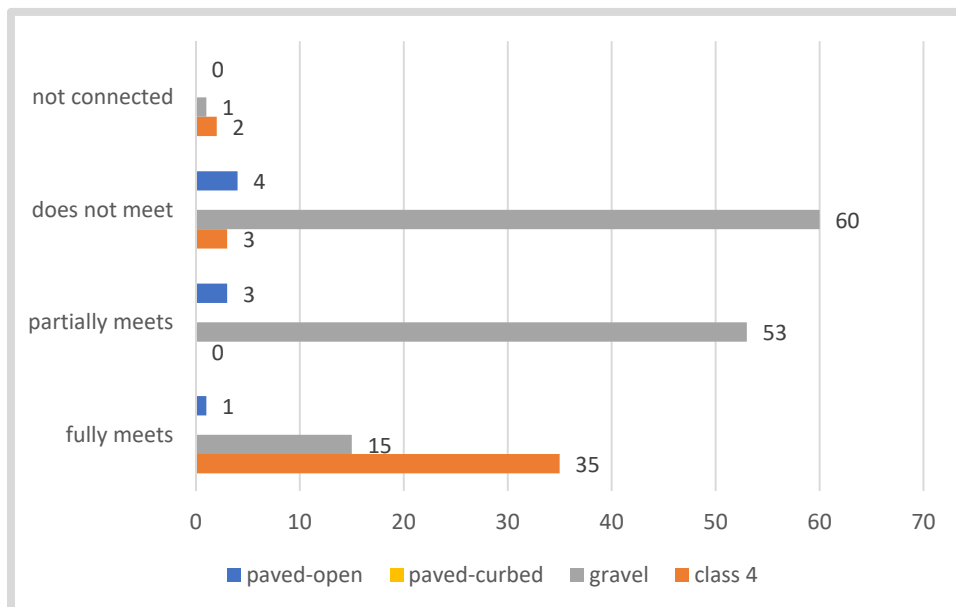
The following bar chart depicts the scoring breakdown (fully meets, partially meets, does not meet) by road type for hydrologically connected road miles within the town’s total road miles.
